# MATERIAL NEEDS AND RELIABILITY CHALLENGES IN AUTOMOTIVE PACKAGING UNDER HARSH CONDITIONS

Varughese Mathew  
NXP Semiconductors  
6501 William Cannon Drive, Austin TX, USA

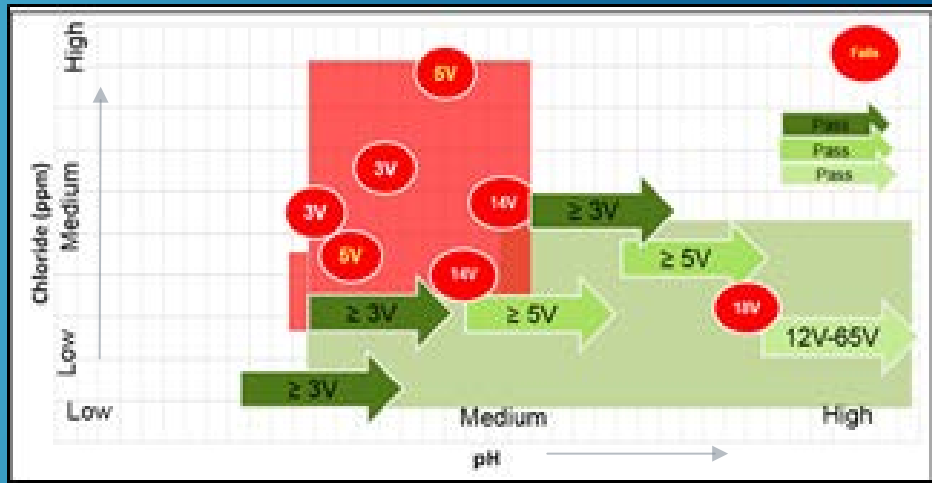
Influence of pH , Cl concentration and bias voltage on CuWB reliability

- pH and corrosive ionic concentration( Cl ) of the mold compound matrix along with applied bias determines/influences CuWB reliability.
- As the biased voltage increases either the pH should be higher towards the neutral region or the Cl concentration be lower in order to avoid a corrosive opening and CuWB failure.
- Bromide ions can also cause corrosion in an additive fashion with Cl.
- Some ions in the mold compound matrix is beneficial or benign.

If the mold compound matrix Cl concentration is kept low with a pH high, even at a relatively high voltage ( studied up to 65V) no corrosion failure observed.

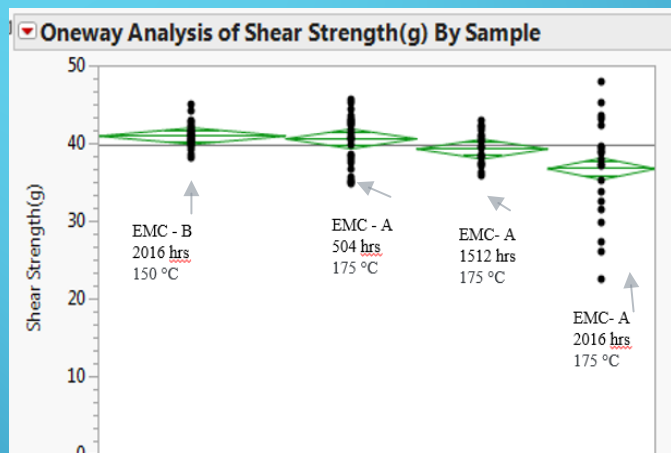
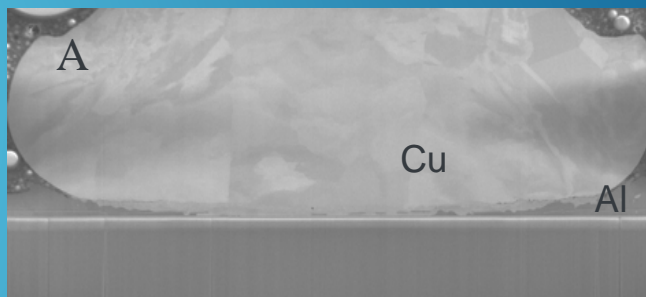
Copper WB ball shear strengths after HTSL for CuWB dies encapsulated with sulfur compound containing mold compounds ( Sulfate – A- 35-40; B- 40-45 ppm).

FIB cross-section of CuWB ball bond after 2016 hours of HTSL at 175 °C - (A) – CuWB ball bond (B) Cu-Al interface (C) EDX spectrum of site 4 (D) EDX spectrum of site 5.

- No gaseous sulfur compound detected at high temperatures (up to 200 C)
- Bare Cu wire( 1mil- passed AECG0 -2X conditions.

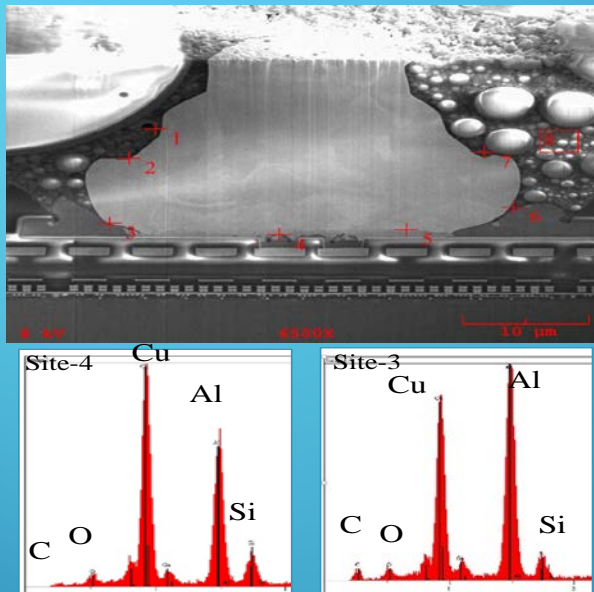
(8.8 ppm sulfate) after 1008 hrs. of HTSL stress.

The CuAl IMC – Al interface was found to be intact and not corroded. No significant corrosion of any part of the ball bond. EDX at various sites did not indicate presence of S.

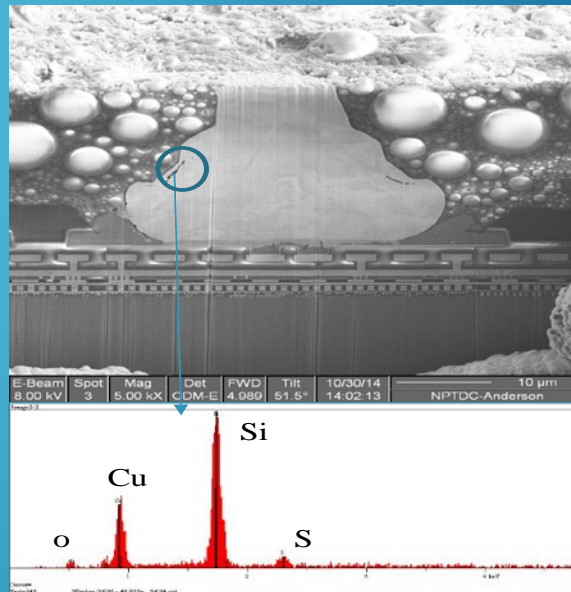
(34.5ppm sulfate) after 1008 hrs. of HTSL stress.

No corrosive opening occurred at the CuAl IMC-Al interface. Some level of copper corrosion (voiding of copper) close to the periphery of the CuWB ball bond. S is detected in the area. No open failures.

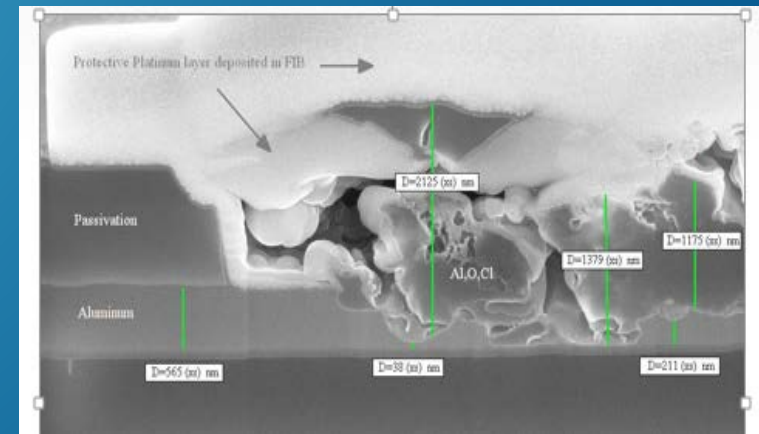
FIB Cross-section of the corroded pad

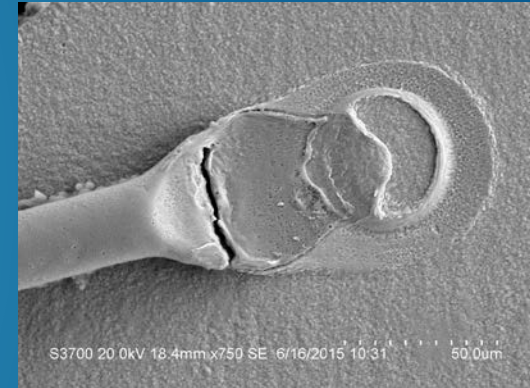
Heel Crack

- A major difficulty in achieving AEC Grade 0 reliability is second bond delamination followed by temperature cycling.
- For lead frame products, some of the main material considerations are wire type, epoxy mold compound (EMC), die attach (DA) materials and lead frame/die design features.
- Lead frames with roughened surfaces, less Ag plating area, appropriate LF design features, die/ LF design, will help to overcome this challenge.
- Mold compound formulation can also be engineered to improve LF- mold compound adhesion.
